Critical Motor Failure within a Large Medical Equipment Manufacturer

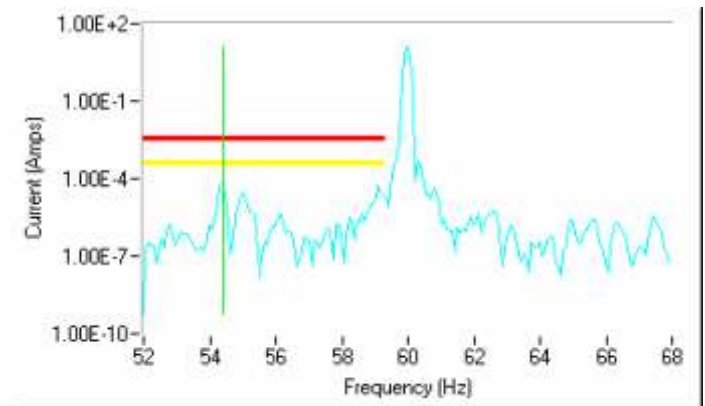
Diagnoses of the data revealed a definite trend in the life of the motors. The motors that were recent replacements were running at over 110 percent load and as they aged their ability to carry the extra load apparently diminished until failure. Some of the motors developed broken rotor bars and others had stator related failures due to the excessive heat.

Figure 1 is representative of a recently installed motor and, although it shows some stress the rotor is intact. Figures 2 and 3 are typical of motors with four to eight months of operating time. Figure 4 is from motor B-6 and has started showing the results of the stress on the rotor.

As a result of the study performed by Tim Thomas, the motor manufacturer has declined any further responsibility until a redesign of the cooling tower can better define the motors operational requirements and specifications.
