Coal fired plant discovers broken pump with online testing

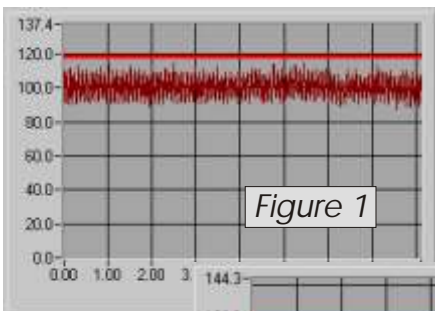
Figure 1

Figure one shows the torque signature of a healthy operating pump, as compared to figure 2 which shows the third pump in the trio. As you can see, the pump under question has a torque of about 75% of the torque of the healthy pumps, meaning it was operating well below its potential efficiency. In addition the torque band is too wide and varies dramatically. All of this information captured by the Explorer provided conclusive evidence for the removal of the pump, which was not previously a priority. Upon examination by a diver, the plant learned that the end bell of the pump had fallen off, reducing the pumps productivity. It was able to be repaired and returned to full service in a short amount of time.
