Monitoring and Diagnosing Problems within Variable Frequency Drives in the Field

E. Wiedenbrug, M. Sanford – Baker Instrument Company, K. Deverell – RCM Technical, Inc. G. Galea – Leeson Canada.

Abstract: Predictive Maintenance professionals typically don't have the luxury of owning their variable frequency drive (VFD) vendor's software that identifies many of the motor-load fault mechanisms. The complexity of the symptoms exceeds the common RMS handheld instrumentation that is available. This paper presents three VFD applications and their diagnoses using modern field instrumentation.

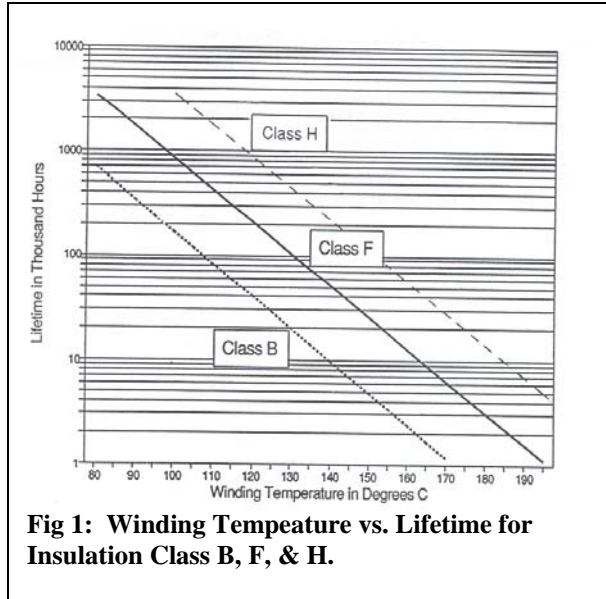
A plant in Washington State was concerned with high operating temperatures of a VFD operated motor. This motor is a 10-year old Design B – 460V 60hp – TEFC 6-pole. The common rule of thumb regarding insulation life is that for every 10°C above rated temperature a winding operates at, the insulation's life drops by half. This is illustrated in Figure 1.

Fig 1: Winding Temperature vs. Lifetime for Insulation Class B, F, & H.

To apply this concept, a motor operation 30°C above its insulation rated temperature reduces a potential life expectancy of 20 years to only 2.5 years.

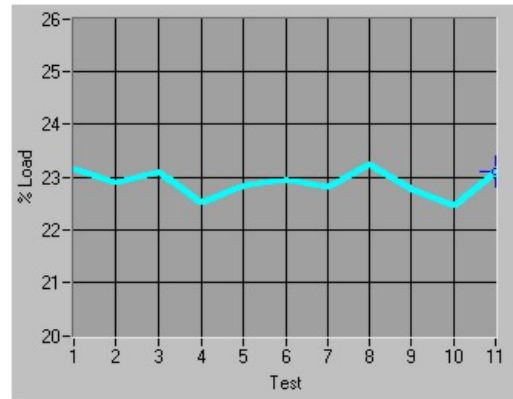
These critical 1hp motors are monitored 24/7 and warrant the installation of logging A-phase state current levels. Stirrer 2 showed an increase in the stators current over the previous two days. In order to avoid the unplanned downtime and the costly loss of production, the root cause of the problem needed to be found. Both stirrers were analyzed with the Baker Explorer. The most likely source of the problem is related to the load of stirrer 2. Figure 4 displays the load of stirrer 2, for 11 subsequent tests, showing a constant load level for all 11 testes between 22.5% and 23.2% load. Stirrer 1 was also checked and similar results were obtained.

Figure 4: Estimated % load vs. number of test.

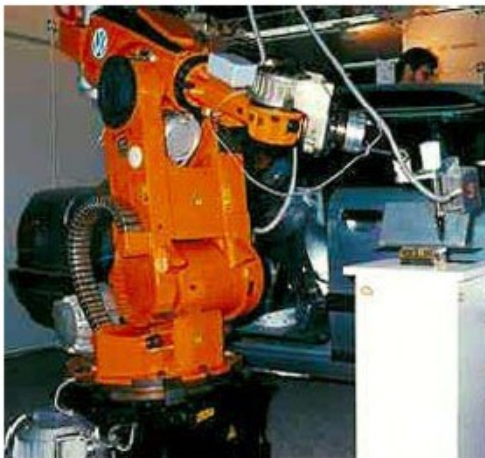
This final case study illustrates the wide range of information available along with the areas of future advancements that still need to be developed. A modern car manufacturing plant is highly automated, using hundreds of robots to meet the production requirement of more than a car a minute. These robots are operated with one or two AC servomotors in each joint. In order to achieve the fastest operation, the AC servomotors are linked to a mechanical brake to assist deceleration.

Fig. 6: Typical car manufacturing robot.

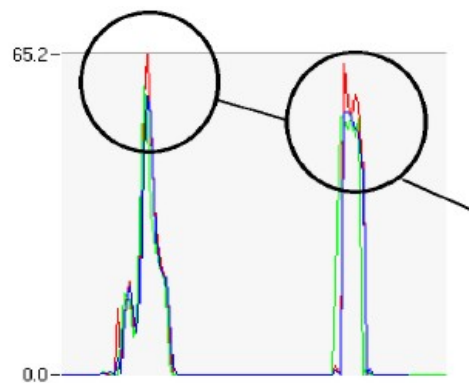
Fig. 8: Three runs, lined up. Red – no fault. Blue, Green – fault.

The traces correlate well with each other, however, the peak input power is higher where the mechanical break assisting the motor has been deactivated. This visual proof verified the success of the first stage of the project.

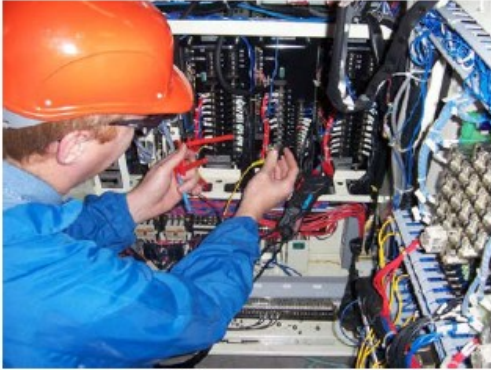
The instrument is connected to the robots currents and voltages via the MCC (Motor Control Center). This leaves the robot out of sight, making synchronizing of data impossible. Figure 7b shows the instantaneous sum of powers for both data acquisitions. An algorithm allows super imposing of traces taken at different times. Figure 8 shows three superimposed acquisitions of input power. The red trace is a healthy servomotor, whereas, the blue and green traces display data with a malfunctioning brake.

Fig. 9: Connecting in the MCC.

Stage 2: Hardware efforts are currently under way to integrate a safe low voltage connectivity package for data gathering for up to 8 servomotors via one connection without opening the MCC. Software efforts aim at automating the pattern recognition and alarm based assessment, enabling high volume testing with reduced acquisition and analysis. This is necessary for this type of operation since this manufacturer has in excess of 200 robots in just the paint shop with 6 servomotors in each robot. The connections, shown in Figure 9, data acquisition and analysis took approximately 10 minutes- per unit. With this time requirement and the need to identify faults quickly the estimated 5 weeks to complete one complete route is prohibitive. The estimated time to failure for a servomotor, once the brake fails, is only a few days and the cost of adding more staff is unlikely. The use of multi-acquisition points would cut the testing time drastically, making the equipment efficient and cost effective.
