Power Plant Avoids Cost of Motor Replacement

In December 2004, a 125hp Screen Refuse Pump was found to be running hot and drawing excessive current. A first thought was to replace the motor with the spare from the warehouse. But what could be causing the excessive current draw?

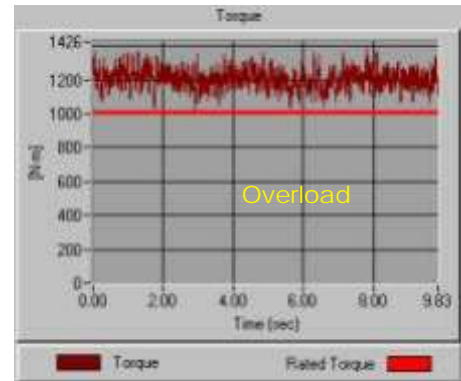
The load profile showed higher than rated values. Maintenance history research revealed that the impeller had been replaced in October 2004. It was discovered that a 17 inch impellor had been installed instead of the required 15.75 inch impellor. A properly sized impellor was installed, lowering the amperage to the expected values.

The Explorer testing played a major role in ruling out a motor problem and going after the pump. Without the Explorer data it would have been likely that the motor would have been replaced at a cost of over \$23,000, and the condition would have continued to exist.
